St Andrew's Church Update

Tenterden

St Andrews Church - 8 June 2020

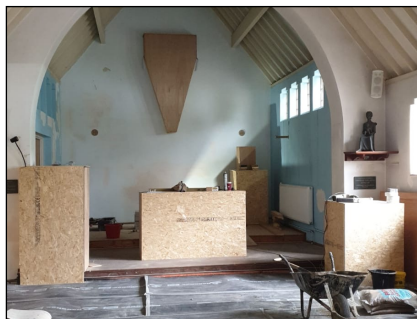
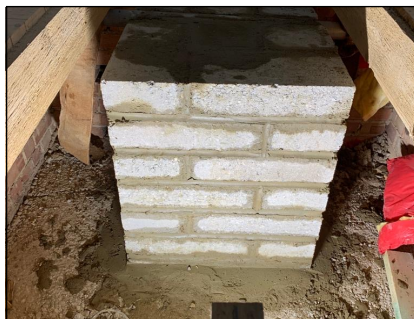
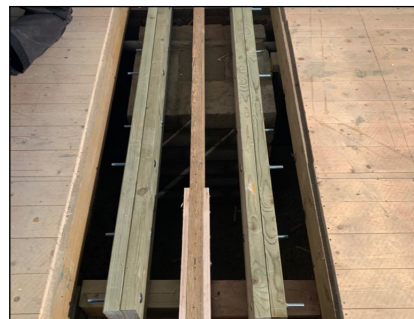
While removing the timber flooring to the Sanctuary area we noticed that the Tabernacle was supported by it's own pillar in order to take it's weight. This made sense, since the Tabernacle is over 400kg. We therefore, dug down 200mm and created a concrete base before building a strong pillar in the new and proposed location of the Tabernacle. This will hold it.

Only completion of the new pillar we followed the structural guidelines and strengthened the Sanctuary floor. This is certainly strong enough now to hold any substantial weight.

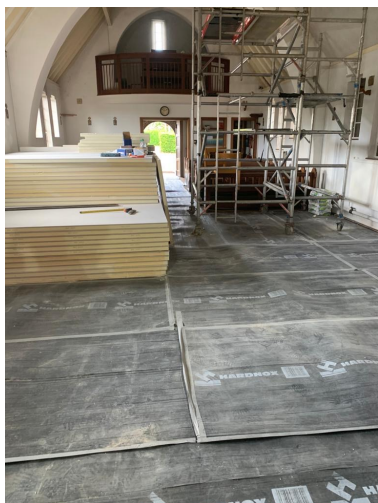
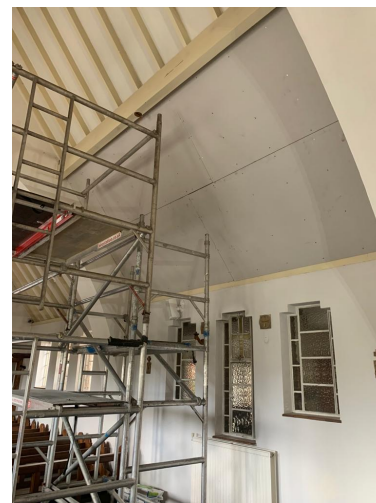
Fortunately with some luck we were able to receive our plasterboard delivery ahead of schedule which meant we were able to start boarding the ceilings. Our aim is to have the ceilings all boarded by the end of Week 3 which gives us a good window to tape & joint.
